**FINAL**  
KNKT. 10.06.11.04

**Aircraft Accident Investigation Report**

**PT. Alfa Trans Dirgantara  
PA 34-200T ; PK-SUV  
Halim Perdanakusuma Airport, Jakarta  
Republic of Indonesia**

**20 June 2010**

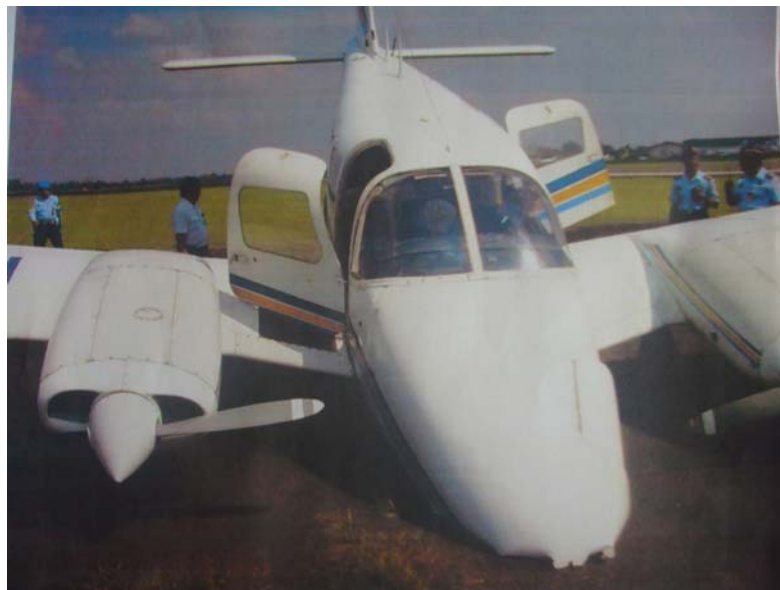
The nose section of the aircraft was damaged, and the propeller blades of the left engine were bent.

**Figure 1: PK-SUV accident site, nose section on runway, nose landing gear was not extended**

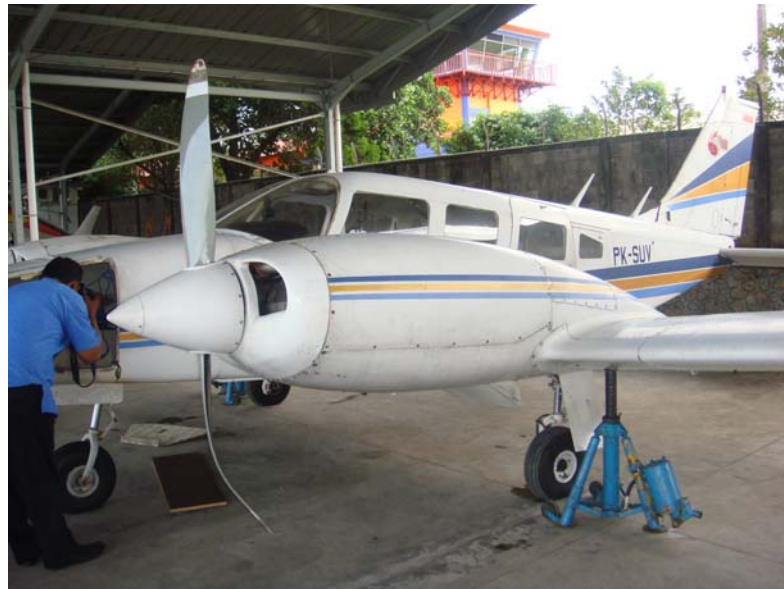
**Figure 3: The aircraft was intact, left engine propeller blades were bent, nose section was damaged**

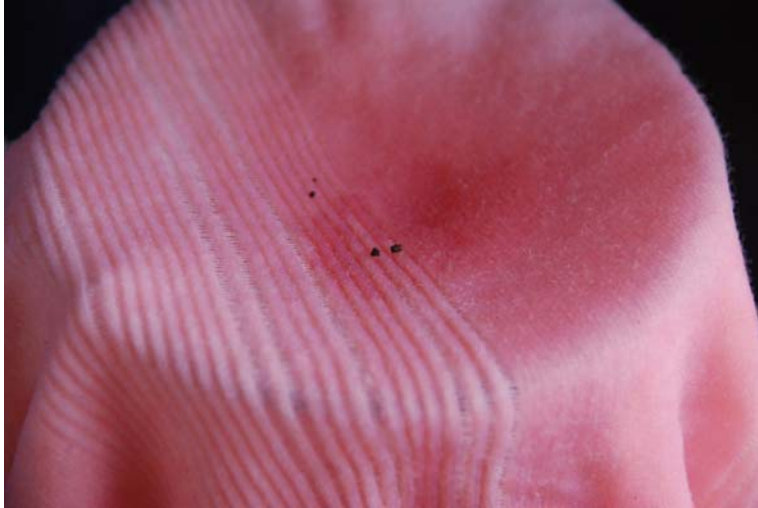
The investigation revealed some dirt in the hydraulic system pipe between nose landing gear actuator up line and restrictor on the up line pipe. The dirt diameter was bigger than the restrictor hole one.

The investigation revealed some dirt in the hydraulic system pipe line between nose landing gear actuator up line and restrictor on the up pipe line. The down line flow of landing gear hydraulic system was block at the nose landing gear actuator restriction valve “0.31 diameter”, may cause the nose gear stuck at up position. The nose landing gear could not be extended, even though the pilot using the free fall control, due to unreleased hydraulic pressure in the up chamber of nose landing gear actuator.

The investigation was unable to find the source of the dirt in the hydraulic up line to the nose landing gear actuator which blocked the restrictor.

**Figure 5: Dirt revealed on the hydraulic line between restrictor and actuator of nose landing gear**

The National Transportation Safety Committee recommends that DGCA should review the Approved Aircraft Inspection Program and maintenance task related to the hydraulic system for the Piper Seneca aircraft maintained and operated by Indonesian Register/Operators.

The National Transportation Safety Committee recommends that PT. Alfa Trans Dirgantara, should use an approved Aircraft Inspection Program/Continuous Airworthiness Maintenance Program to maintain the aircraft.

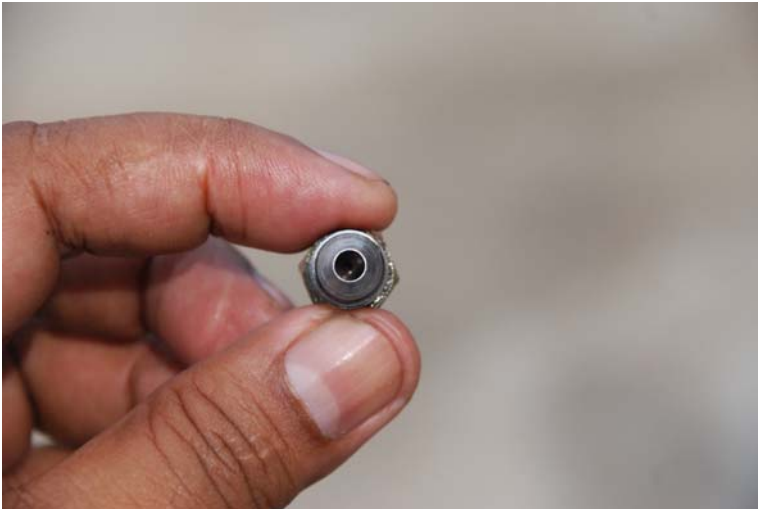
**Figure 6: Hydraulic restrictor 0.31 diameter**

The hydraulic system pipe line between nose landing gear actuator up line and restrictor on the up pipe line. The down line flow of landing gear hydraulic system was block at the nose landing gear actuator restriction valve “0.31 diameters” by some dirt.

The nose landing gear could not be extended due to the down line flow of landing gear hydraulic system was block at the restriction valve 0.31 diameters.
