**Aircraft Accident Investigation Report**

**9M – BDI**

**Cessna 172M**

**42 NM north west of Depati Amir Airport,  
Pangkal Pinang**

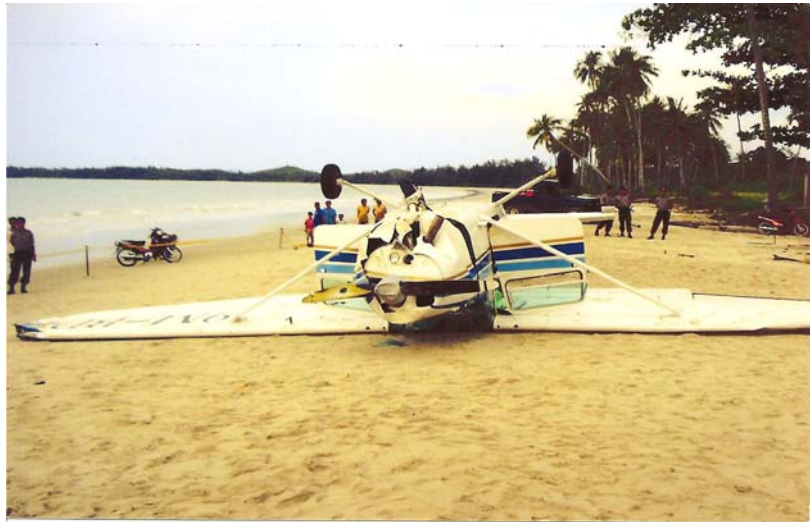
The aircraft came to rest inverted and was substantially damaged, but it remained intact.

Figure 2: 9M-BDI inverted on the beach

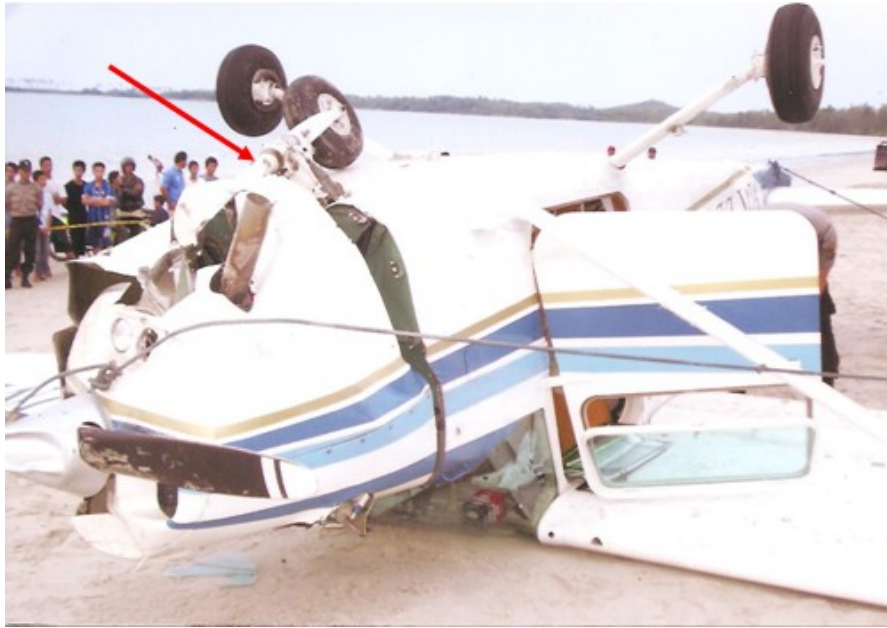
Figure 3: Arrow points to fractured nose landing gear

The main and nose landing gear assemblies were substantially damaged. The nose wheel dug into soft sand during the landing roll and folded rearwards, severely distorting the engine mount and firewall. The propeller blades were bent during impact with the sand. The windshield was fractured.

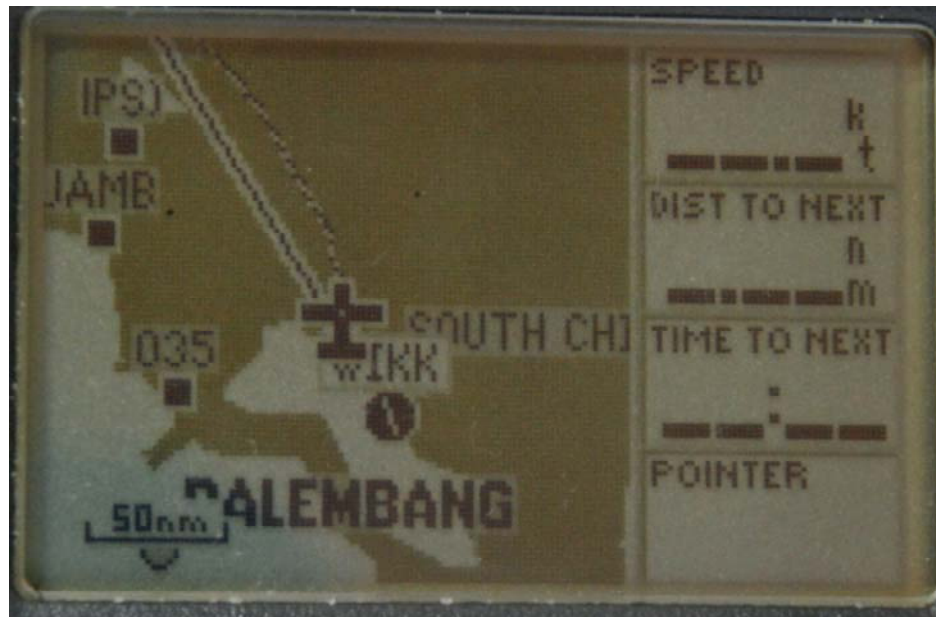
Figure 4: Flight track of 9M-BDI from its on-board Global Positioning System
