KNKT/02.12/04.01.012

**NATIONAL
TRANSPORTATION
SAFETY
COMMITTEE**

AIRCRAFT ACCIDENT REPORT

AN-72-100 ES-NOP

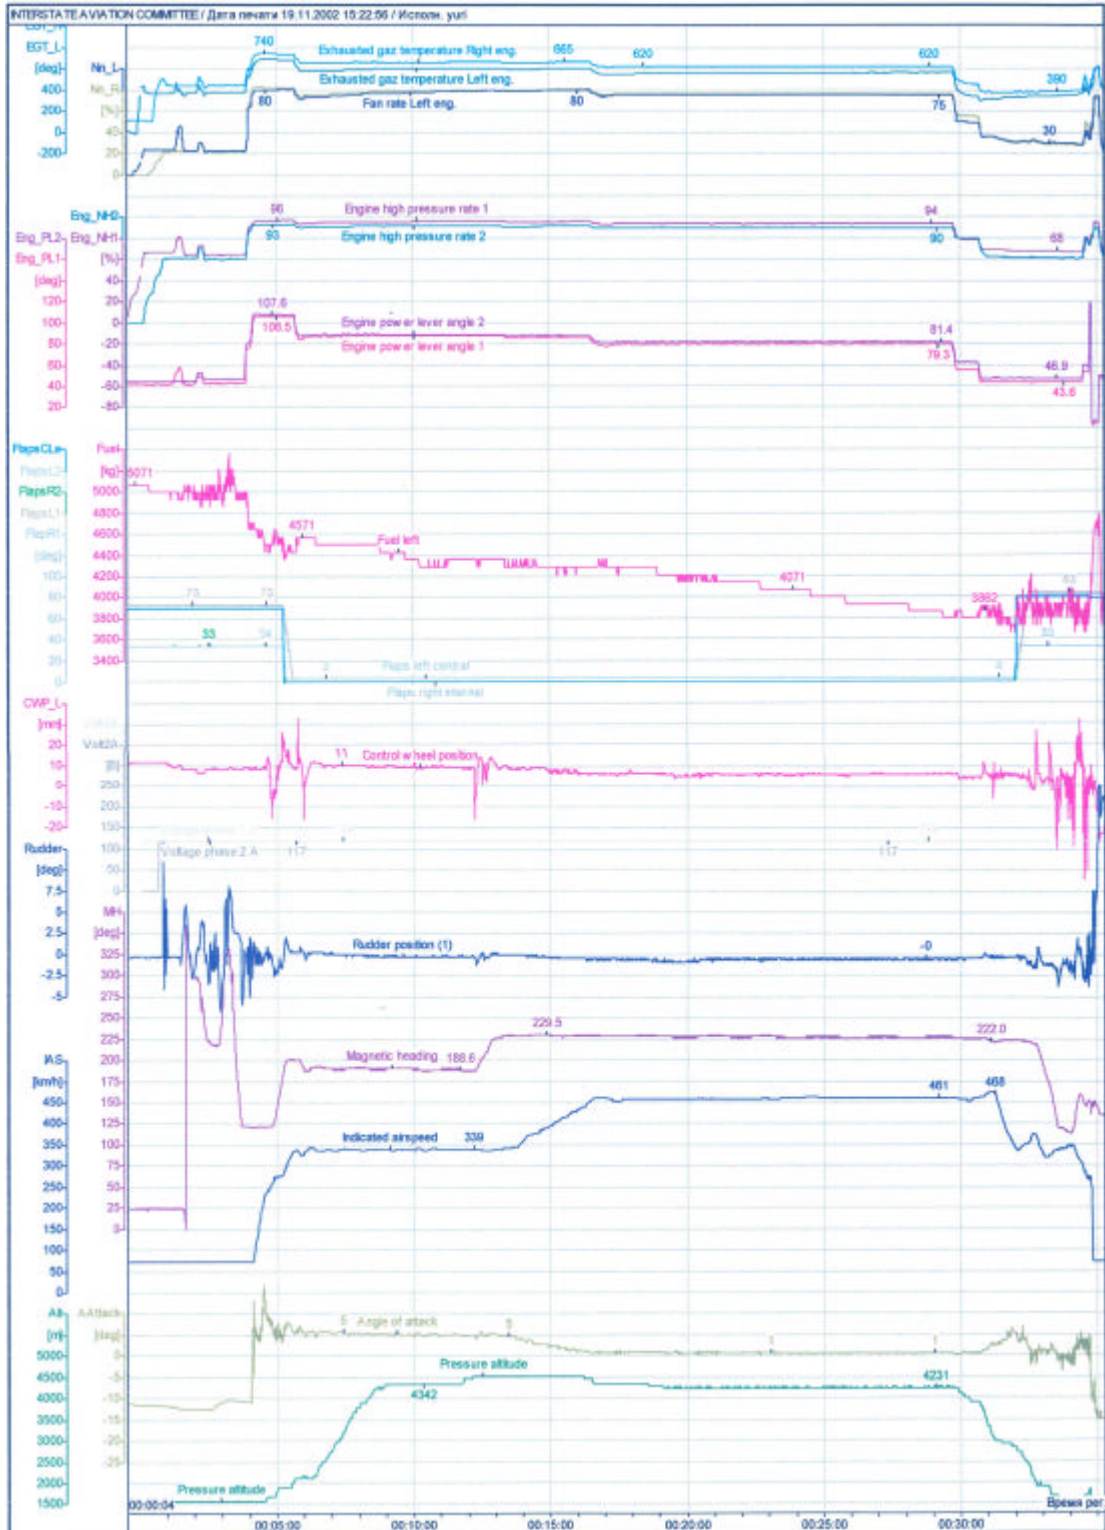
Fig. 2 An-72 ES-NCP21.04.02 at Wamena (Indonesia) flight parameters

Therefore, it can be concluded that the aircraft was over speed upon the accident landing. The FDR analysis also noted that the aircraft never fully deploy its flap due to over speed on final (see 0).

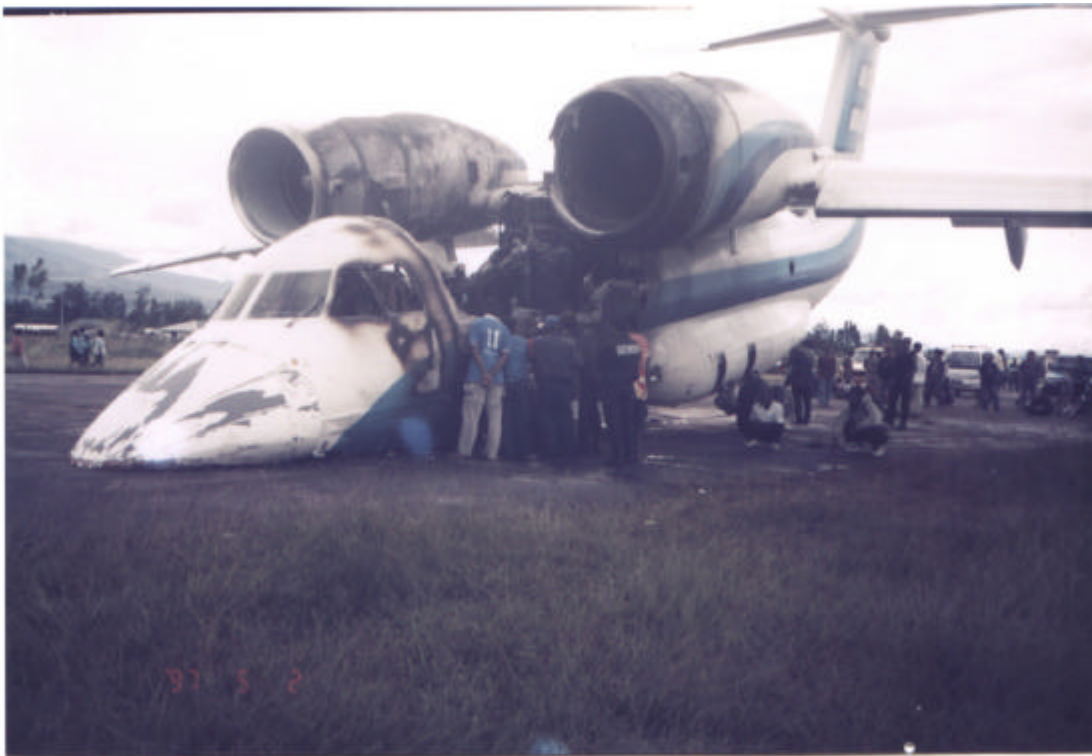
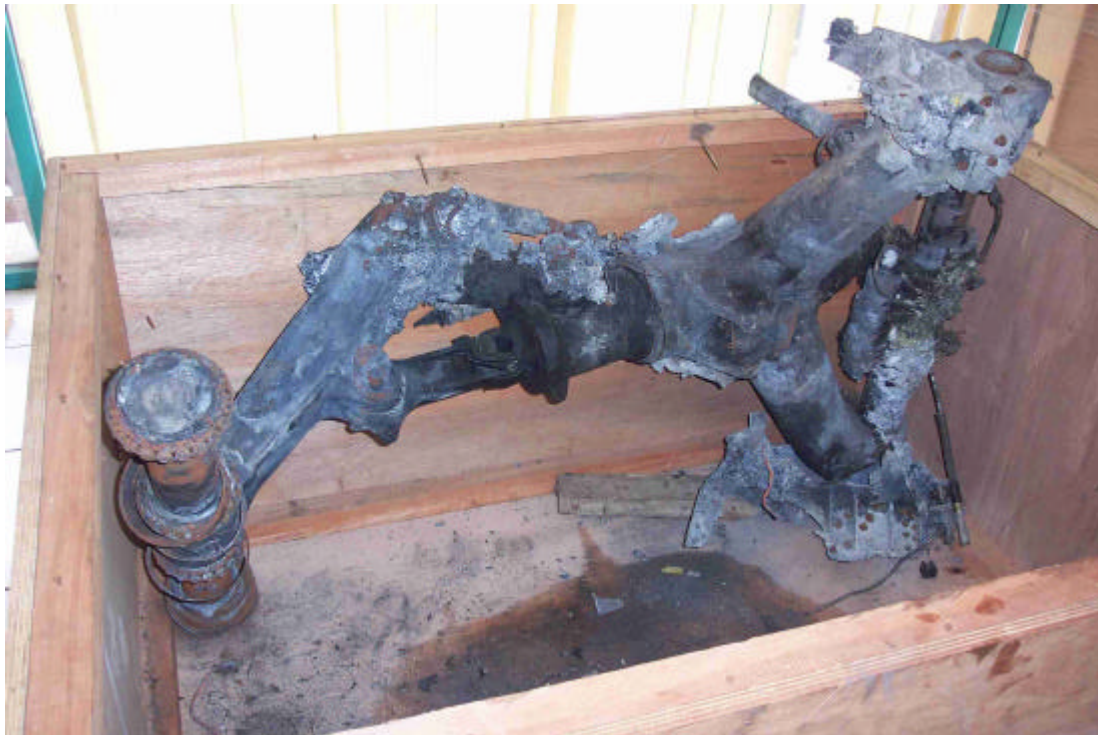
**Appendix C - Aircraft damage and
Landing gear**

The aircraft was found in nose down position, indicating the nose wheel has collapsed. The collapsed nose landing gear was found detached from the airframe, when the aircraft lifted to be moved. Cockpit and front end of airframe (in front of the wing) was found completely burnt. The fronts of both engine cowlings were also burnt. The front tire of right main landing gear was blown because of the fire and also the rear tire of left main landing gear.

The nose landing gear was found detached and burned heavily (see Appendix C -). The fracture surfaces at the landing gear strut mounting to the fuselage frame were damage by fire and therefore recognition on any indication of fatigue was not possible. The tires were burn out by the fire. The front part of then landing gear strut was damaged from scraping with the runway. Some melted magnesium alloy from the fuselage was found in the landing gear strut.

Metallurgist and AN-72 engineer determined that the nose landing gear/wheel fail due to static overload from over speed landing. It is very possible that the right main gear touch the runway first due to the maneuver perform on approach, and therefore creating twisting force on the nose gear.
