Aircraft Accident Preliminary Investigation Report

KNKT 09.08.03.02

**PT. Lion Air  
PK – LIL  
Boeing McDonnell Douglas MD-90  
Sukarno Hata Airport  
Jakarta  
Republic of Indonesia**

**9 March 2009**

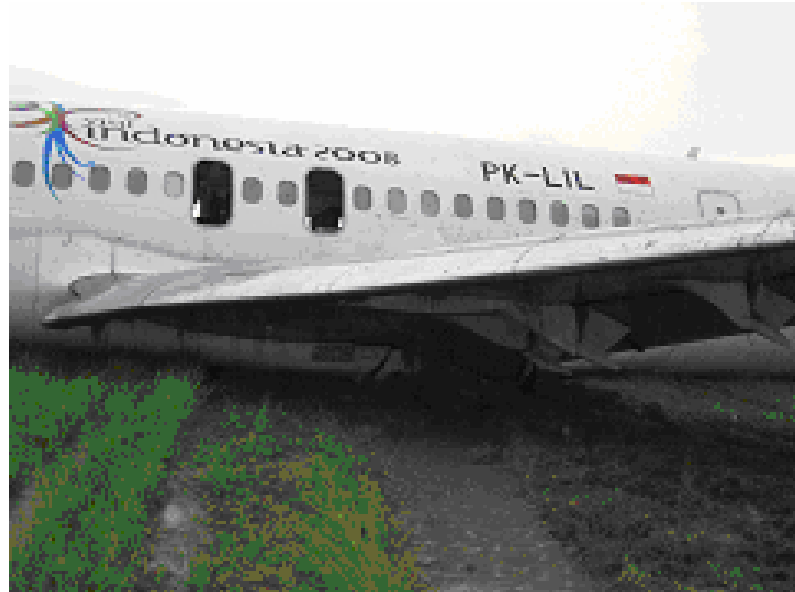
**Figure 1: View from right side of PK-LIL after the accident**

The left main landing gear separated from the aircraft. The right main landing gear collapsed and the landing gear assembly was significantly damaged. Tire number 3 (inboard right main wheel) exploded. The right landing light was broken and was found 45 meters from the landing threshold.

The aircraft remained intact apart the left main landing gear, which separated from the aircraft and the right landing light was found 45 meters from the landing threshold.

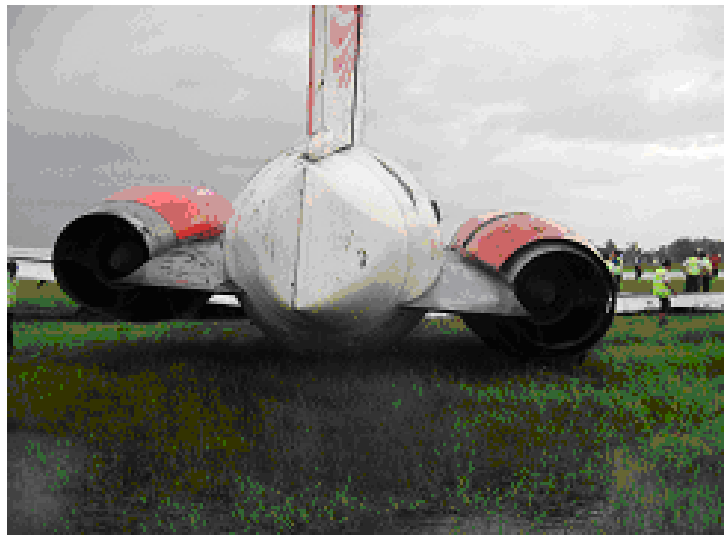
The aircraft stopped at 08:35 on the right side of runway 25L, 1,095 meters from the departure end of the runway on a heading of 152 degrees; 90 degrees from the runway 25L track. The main landing gear was off the sealed runway surface and the nose gear was on the runway.

**Figure 2: PK-LIL at Soekarno-Hatta Airport, Jakarta after accident**
