Aircraft Accident Preliminary Investigation Report

KNKT 09.05.02.03

**PT. Lion Air
PK – LIO
Boeing McDonnell Douglas MD-90
Hang Nadim Airport
Batam-Kepulauan Riau
Republic of Indonesia**

23 February 2009

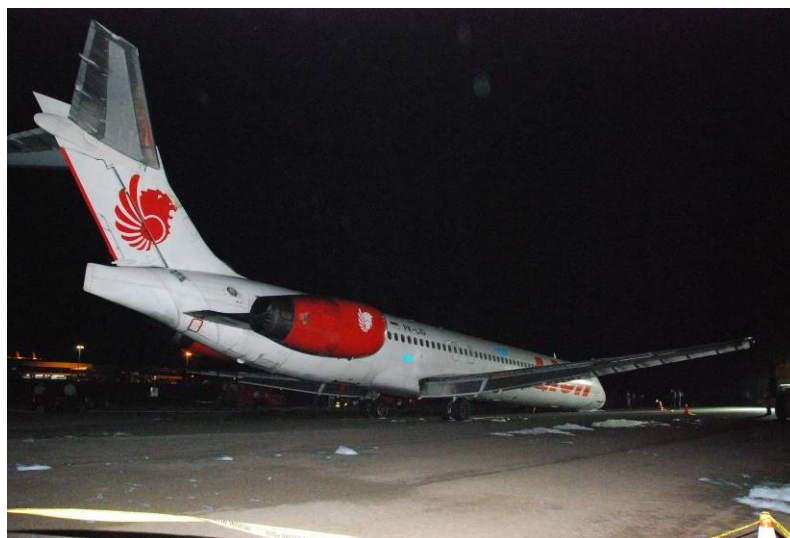
Figure 1: PK-LIO on runway at Hang Nadim Airport, Batam after accident

The nose-section lower fuselage area of the aircraft was damaged due to the landing gear spray deflector striking the wheel bay during the retraction cycles. It was further damaged during the impact with the runway during landing roll.

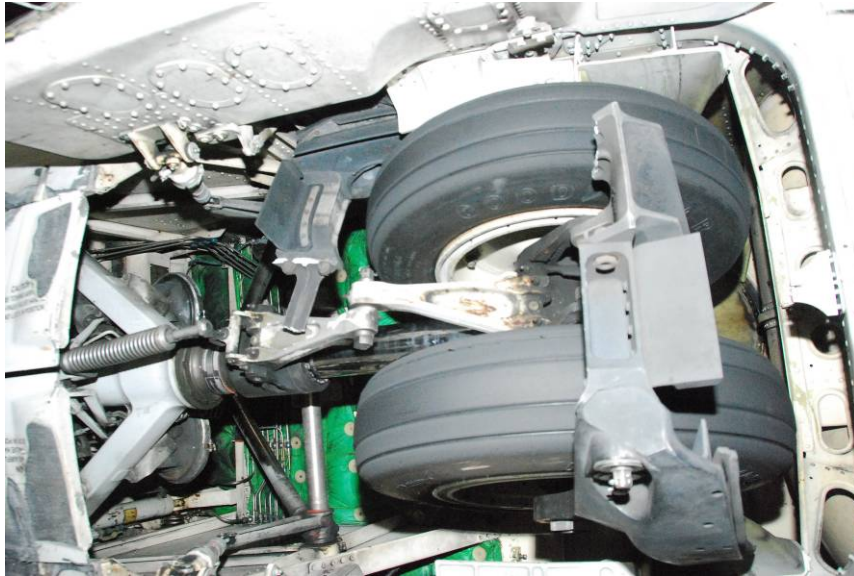
The nose landing gear right spray (water) deflector had fractured and became detached. The center deflector was broken.

The nose gear could not be put in gear down position due to the damage and distortion of the spray deflector, which caused it to jam against the wheel bay structure.

Figure 2 Damaged and distorted nose landing gear spray deflector

- a) The nose landing gear spray deflector fitted to MD-90 aircraft is inspected for cracks at each nose wheel tire change.
- b) The adequacy of the crack inspection/detection procedures.

The National Transportation Safety Committee recommends that the Directorate General of Civil Aviation mandate an inspection requirement, specifying inspection procedures and intervals for crack detection of the nose landing gear spray deflector fitted to MD-90 aircraft.

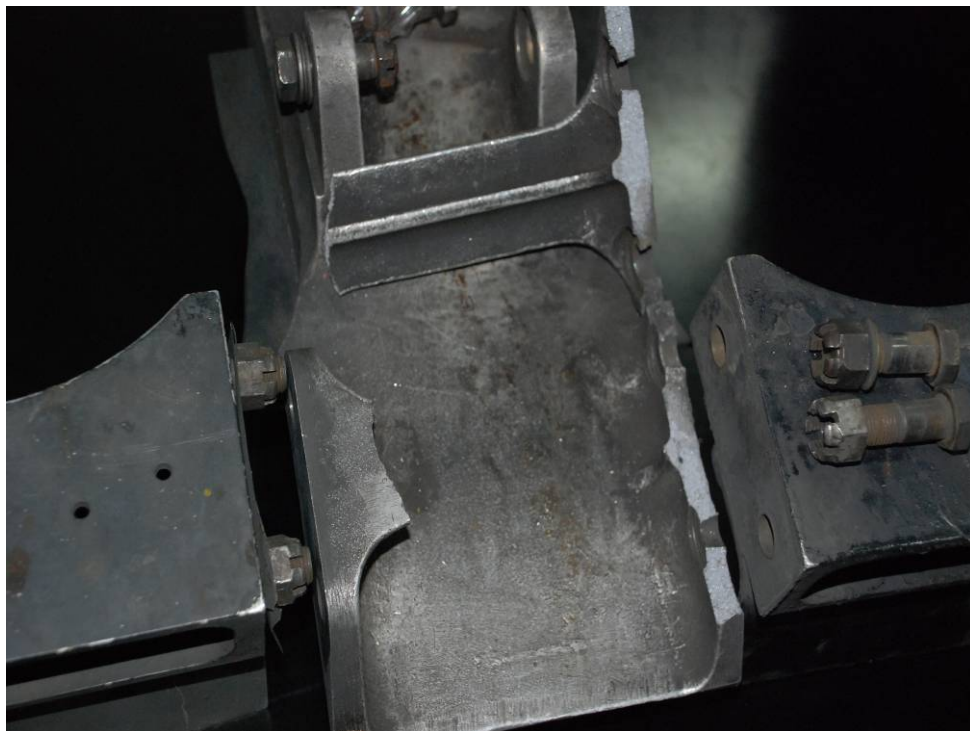
Figure 3 The fracture surface shows a dark colored portion indicating a pre-existing crack.
