**Aircraft Serious Incident Investigation Report**

**PT. Merpati Nusantara Airlines**

**De Havilland DHC 6-300 Twin Otter; PK-NUH**

**17 October 2011**

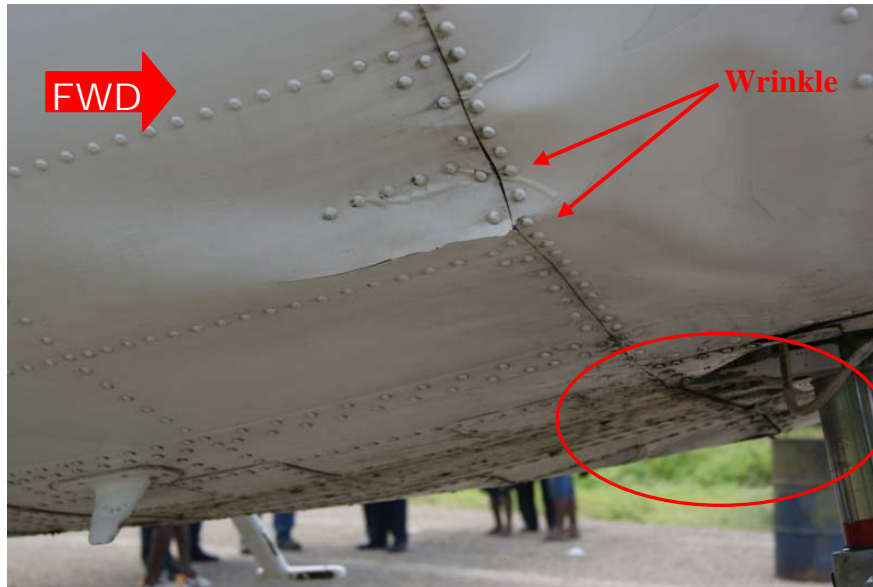
**Figure 2. PK-NUH Station 60 (Lower Fuselage) Section**

- Lower forward fuselage Station 60 twisted,
- Right wing leading edge damage,
- Right main landing burst,
- Left compressor block upper and lower broken,
- Left main gear shifted rearward.

About 18,4 metres from the end of runway 24, there was an scoured mark on asphalt of the runway surface that indicate the aircraft conducted a quick and deep turning (ground loop) on right main wheel. This action caused the right main wheel busted, the left main gear shifted rearward and lower forward fuselage station 60 twisted.

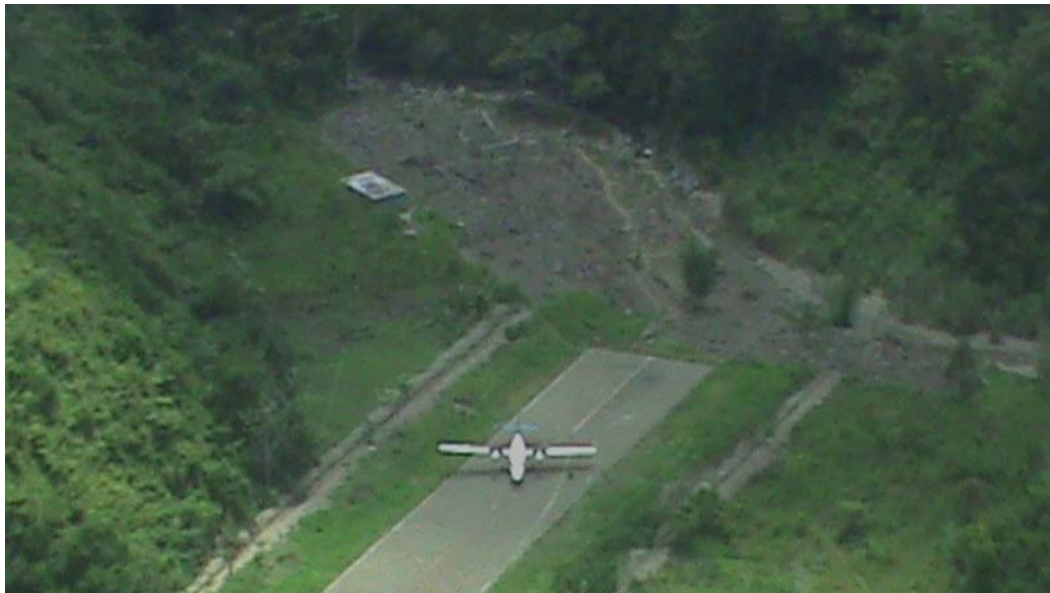
**Figure 5. PK-NUH Final Position after the Occurrence**

The first tire marks indicated aircraft touchdown was found on runway surface about 200 metres from the beginning of Runway 24.

The second tire found about 375 metres from the beginning of Runway 24. The tire marks shown the aircraft was veered to the right side of runway. There was an impact indication on the banana trees mostly due to impact the right wing.

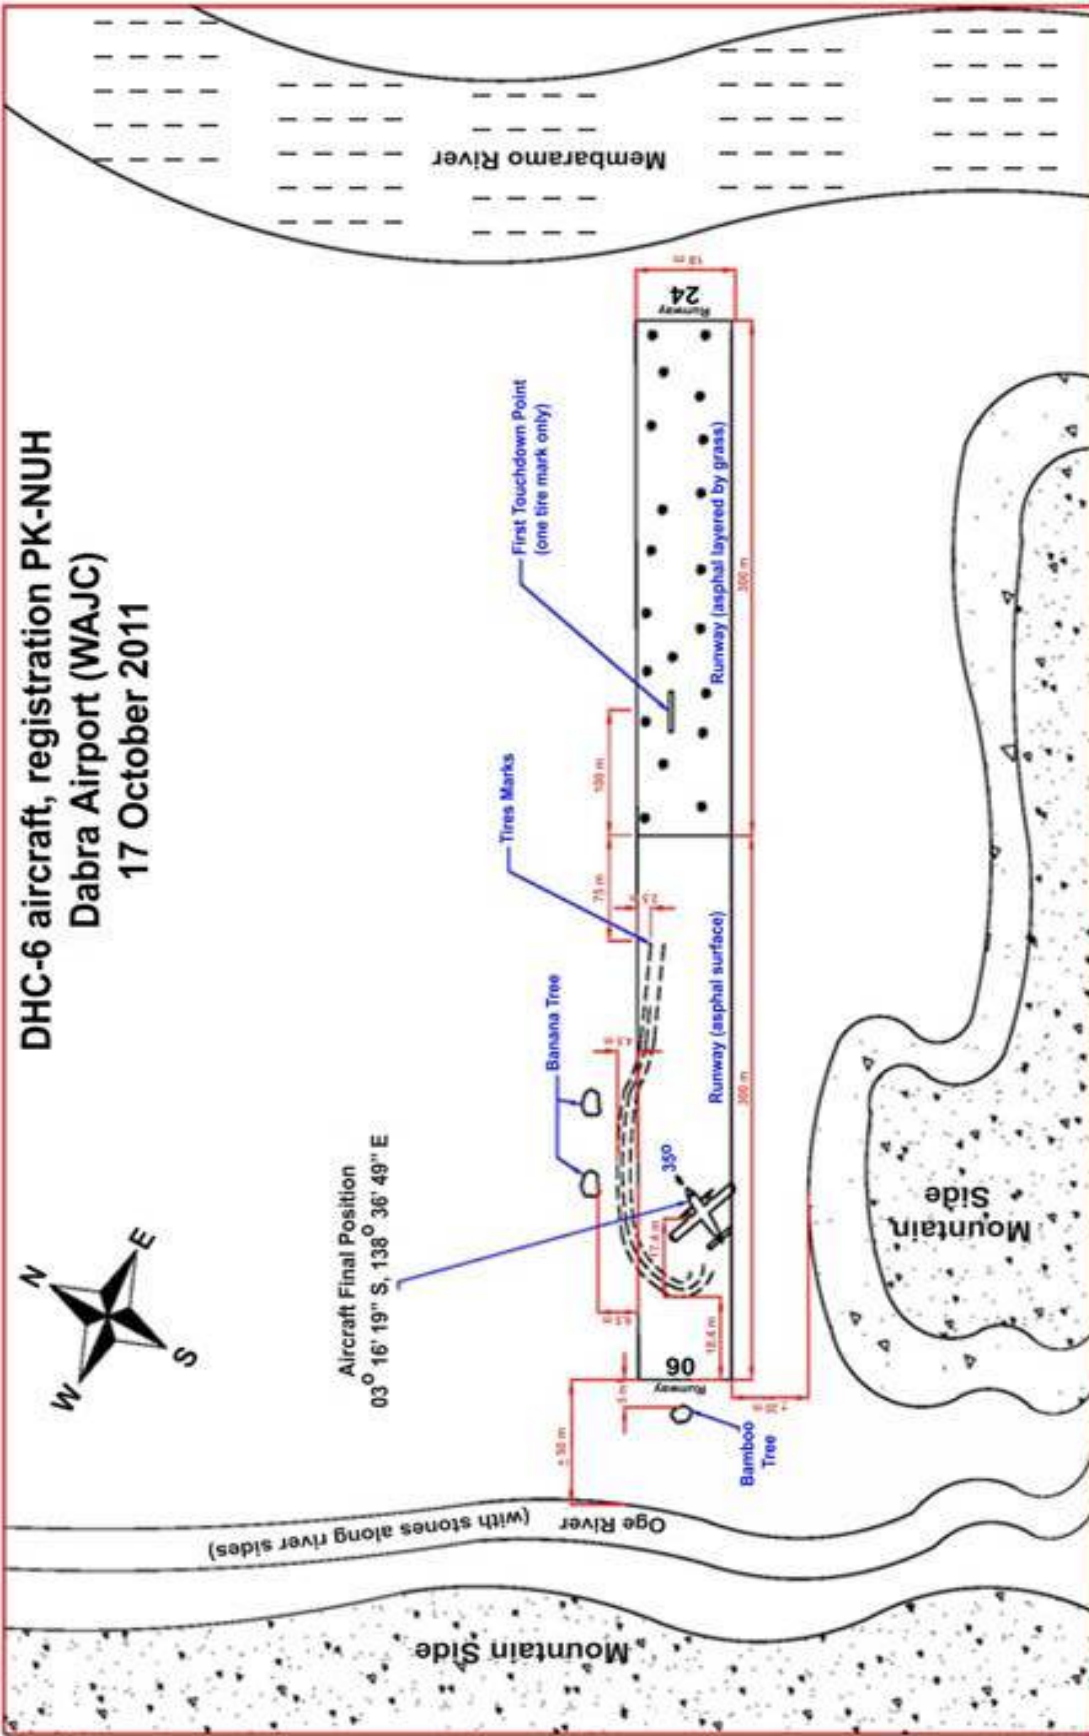
**Figure 7. The Sketch of PK-NUH Final Position**

After the aircraft entering the runway, the flight crew recovered by ground loop about 18,4 metres before the end of runway 24. The aircraft stopped 35.8 metres before the end of runway 24 and heading 35o.
