PRELIMINARY
KNKT.10.01.01.04

Aircraft Serious Incident Investigation Report

Antonov AN-26B; 4L-IFE

Wamena Airport, Wamena, Papua

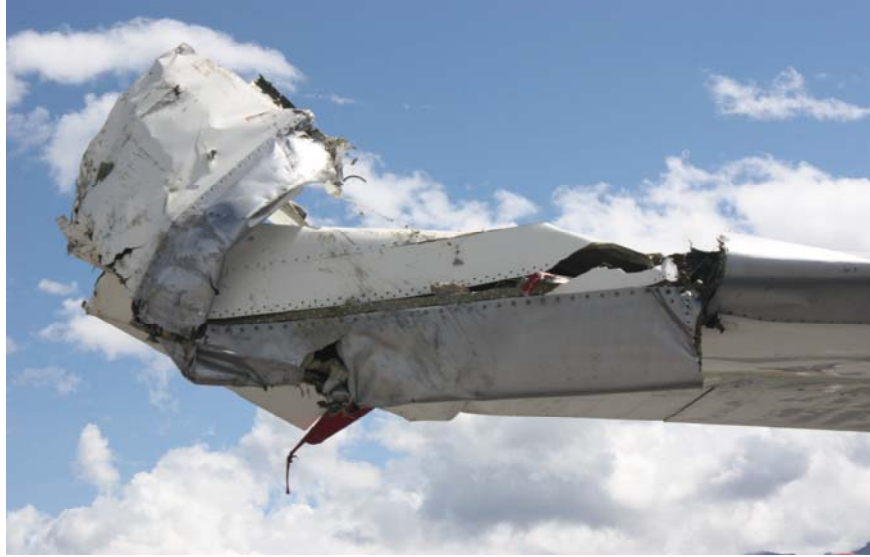
The nose landing gear, right wing tip, lower fuselage, and right propeller were extensively damaged.

Figure 1: The damaged right wing tip

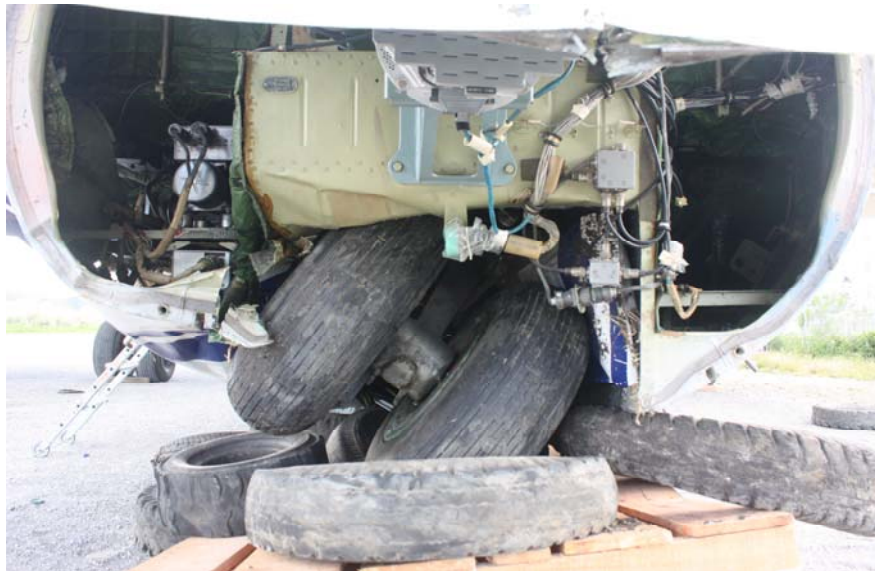
Figure 2: The nose landing gear

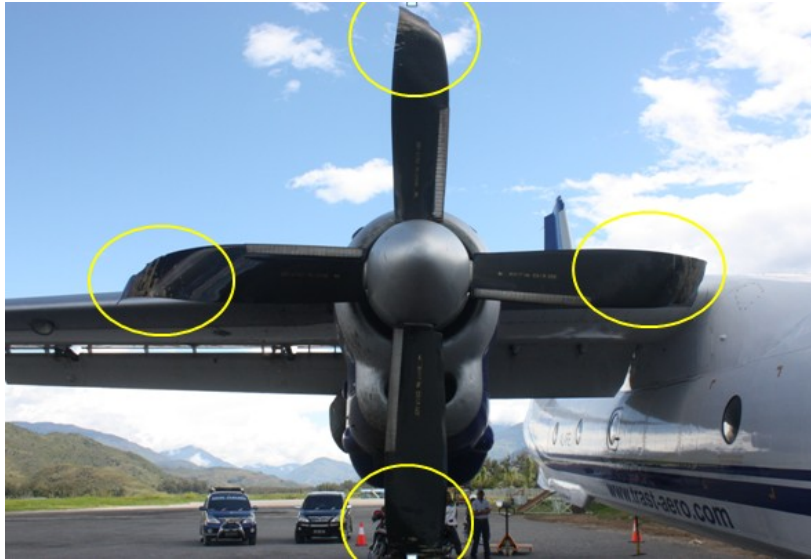
Figure 3: The right propeller blades were bent

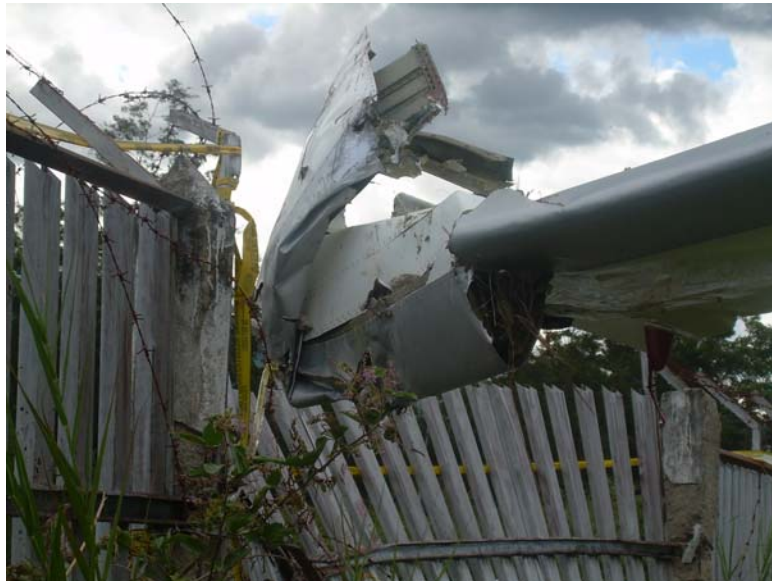
The aerodrome perimeter fence was damaged due to impact by the aircraft's right wing tip.

Figure 4: The aerodrome perimeter fence

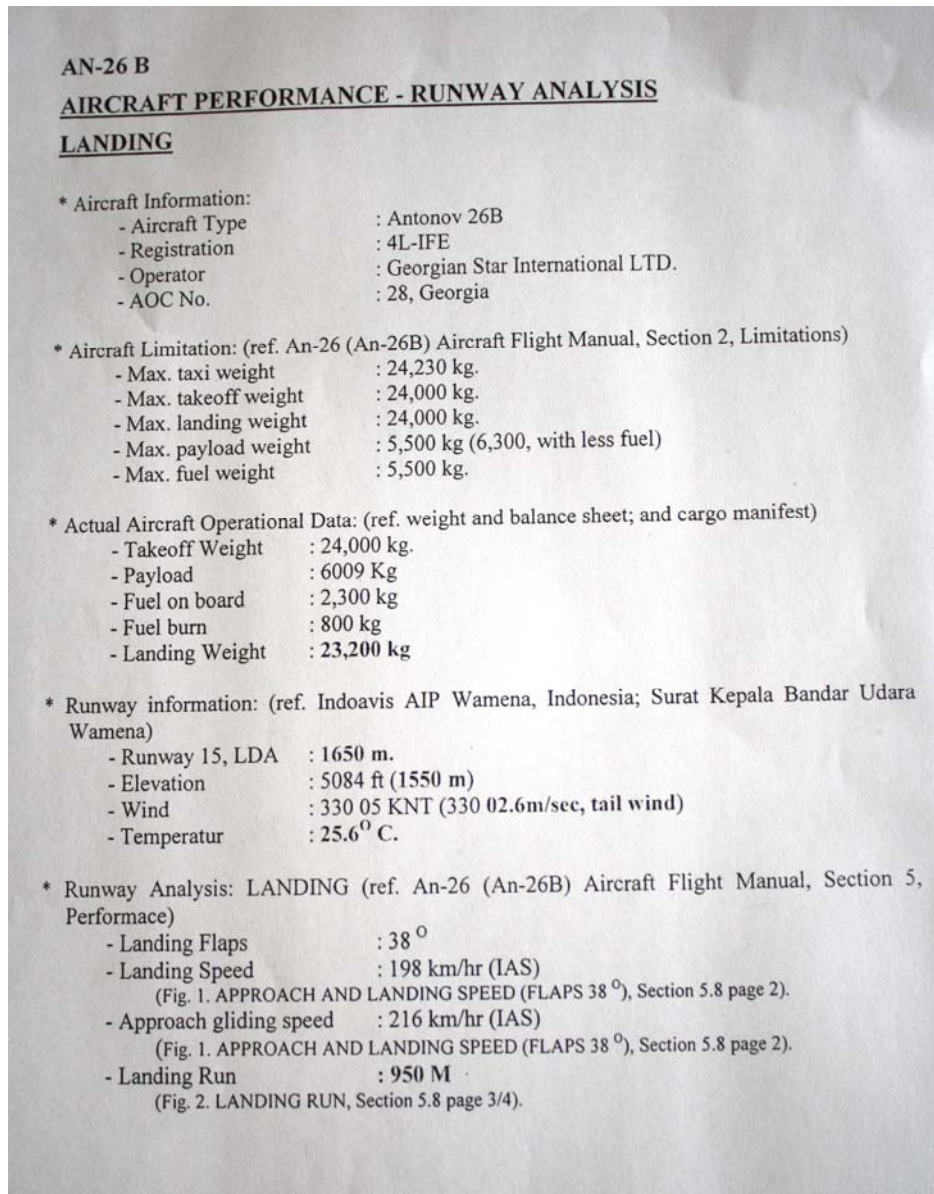
Figure 6: Aircraft Performance – Runway Analysis Landing sheet used by the crew

The following Aircraft Performance – Runway Analysis Landing calculation sheet was provided by the operator as the aircraft performance data used by the crew for the accident flight. The incorrect aerodrome elevation was used by the operator. On 1 December 2009, the Directorate General of Civil Aviation issued a NOTAM that amended the aerodrome elevation from 5,084 feet to 5,430 feet.

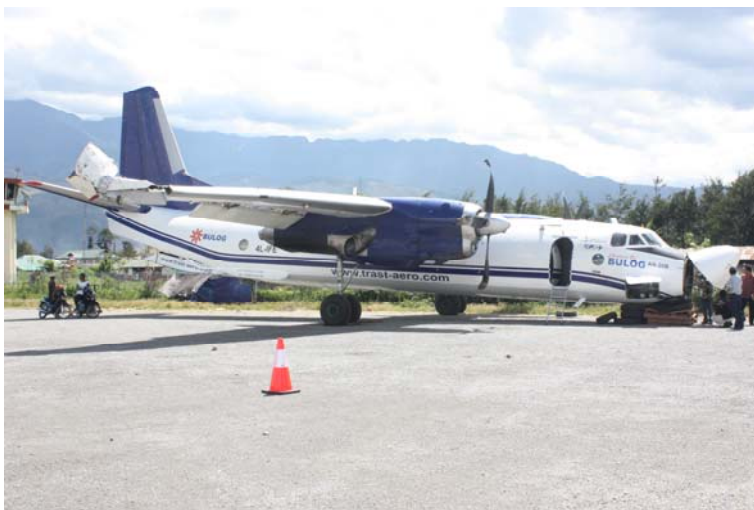
The aircraft overran the departure end of runway 15 and stopped in a ditch. It was substantially damaged.

Figure 9: The substantially damaged aircraft
