PRELIMINARY
KNKT.10.02.05.04

Aircraft Serious Incident Investigation Report

PT. Metro Batavia Airline

Boeing 737-200; PK-YTR

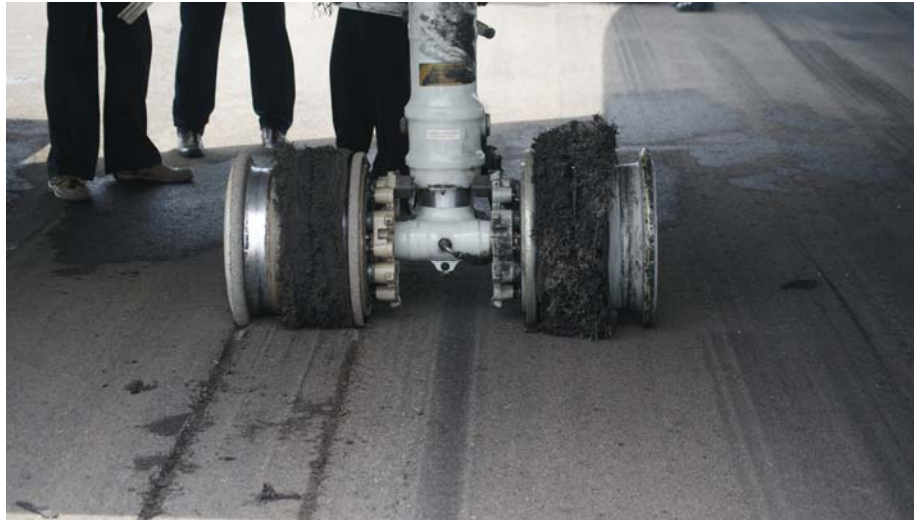
Figure 2: Main landing gear wheels one and two

The aircraft commenced the take-off roll on runway 10 at 0235 UTC¹ (0935 LT). Approximately 300 meters after commencing the take-off roll, main-wheel tire number one (left outboard) exploded followed by tire number two (left inboard) approximately 1,100 meters further along the runway. Both tires shredded and the aircraft rolled along the runway on the wheel rims.

The tires on main landing gear wheels one and two shredded, and tires three and four deflated. There was no other damage to the aircraft.

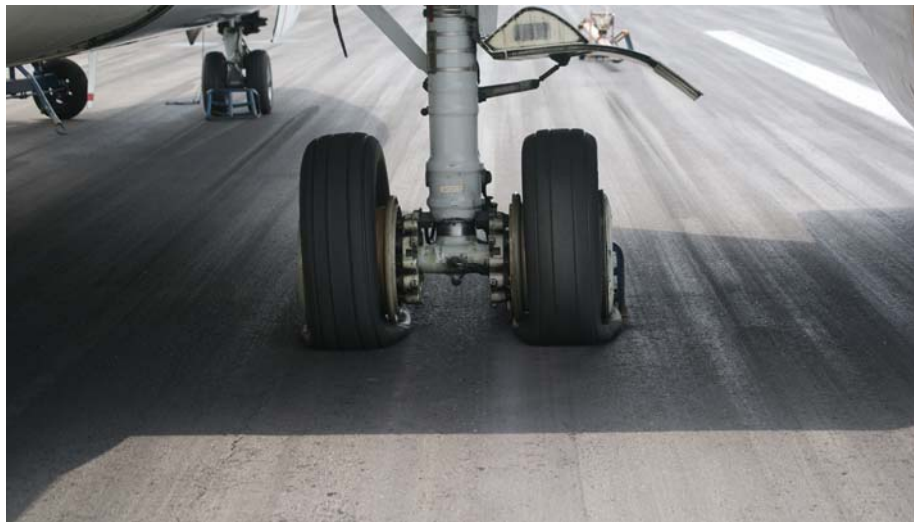
Figure 3: Main landing gear wheels three and four

The copilot decided to abort the takeoff and stopped the aircraft adjacent to taxiway N6, approximately 350 meters from the departure end of runway 10. Tires numbers three and four deflated.

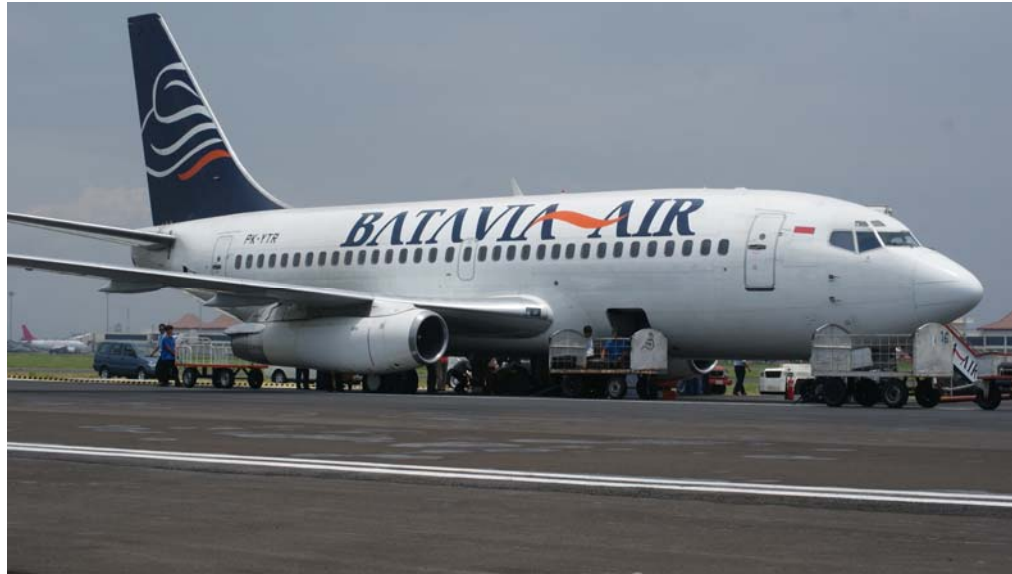
Figure 8: The aircraft at the final position (N6 intersection)

Apart from the main landing gear wheel assemblies, the aircraft was not damaged.
