KNKT/08.26/09.02.39

**NATIONAL
TRANSPORTATION
SAFETY
COMMITTEE**

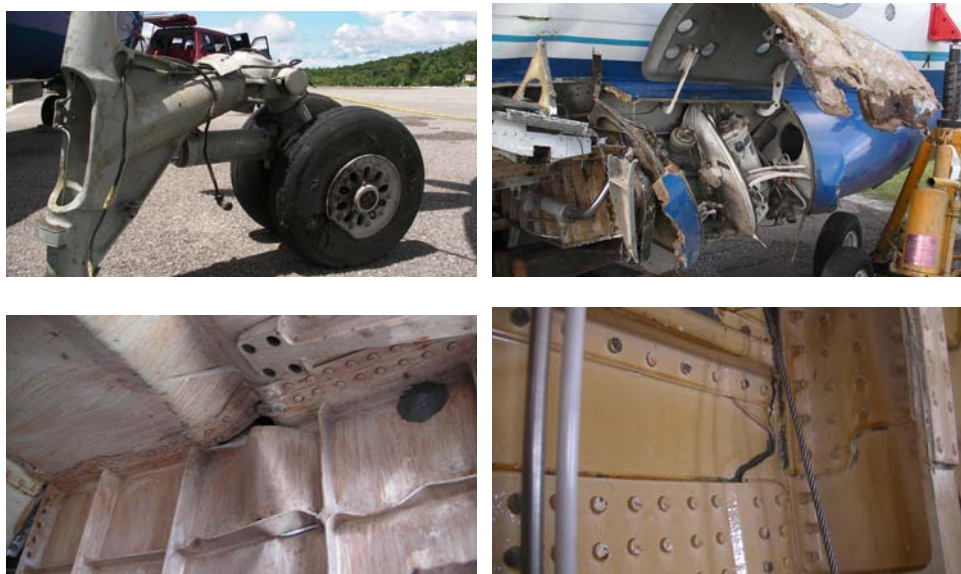
Figure 4: Damaged left main landing gear, landing gear bay, and left fuselage structure
