**FINAL**  
KNKT. 10.06.11.04

**Aircraft Accident Investigation Report**

**PT. Alfa Trans Dirgantara  
PA 34-200T ; PK-SUV  
Halim Perdanakusuma Airport, Jakarta  
Republic of Indonesia**

**20 June 2010**

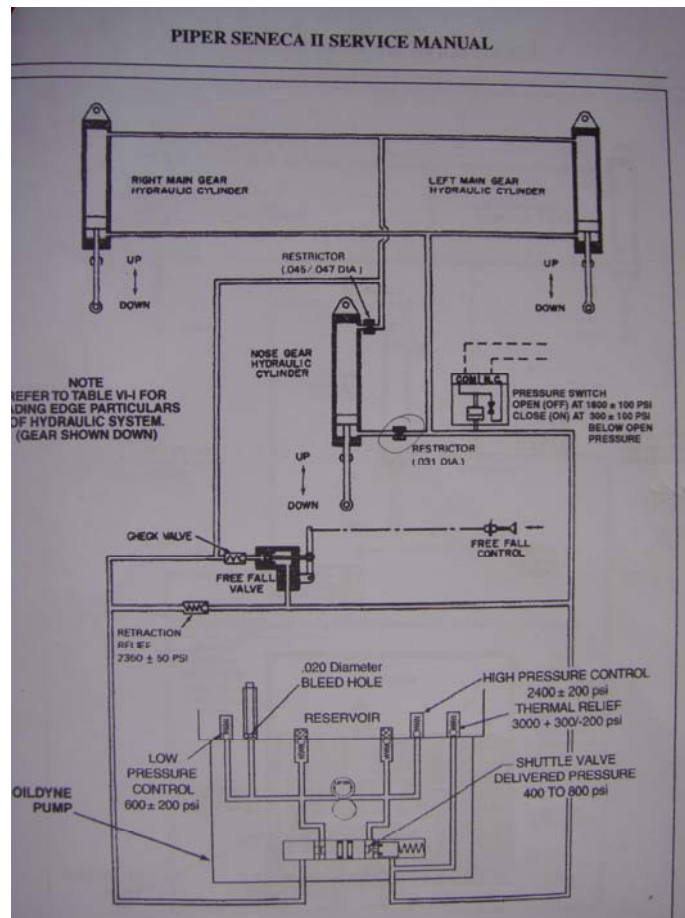
Figure 4: Hydraulic system diagram.

The investigation revealed some dirt in the hydraulic system pipe line between nose landing gear actuator up line and restrictor on the up pipe line. The down line flow of landing gear hydraulic system was block at the nose landing gear actuator restriction valve “0.31 diameter”, may cause the nose gear stuck at up position. The nose landing gear could not be extended, even though the pilot using the free fall control, due to unreleased hydraulic pressure in the up chamber of nose landing gear actuator.

The investigation was unable to find the source of the dirt in the hydraulic up line to the nose landing gear actuator which blocked the restrictor.

The National Transportation Safety Committee recommends that DGCA should review the Approved Aircraft Inspection Program and maintenance task related to the hydraulic system for the Piper Seneca aircraft maintained and operated by Indonesian Register/Operators.

The National Transportation Safety Committee recommends that PT. Alfa Trans Dirgantara, should use an approved Aircraft Inspection Program/Continuous Airworthiness Maintenance Program to maintain the aircraft.
