KNKT/02.12/04.01.012

**NATIONAL
TRANSPORTATION
SAFETY
COMMITTEE**

AIRCRAFT ACCIDENT REPORT

AN-72-100 ES-NOP

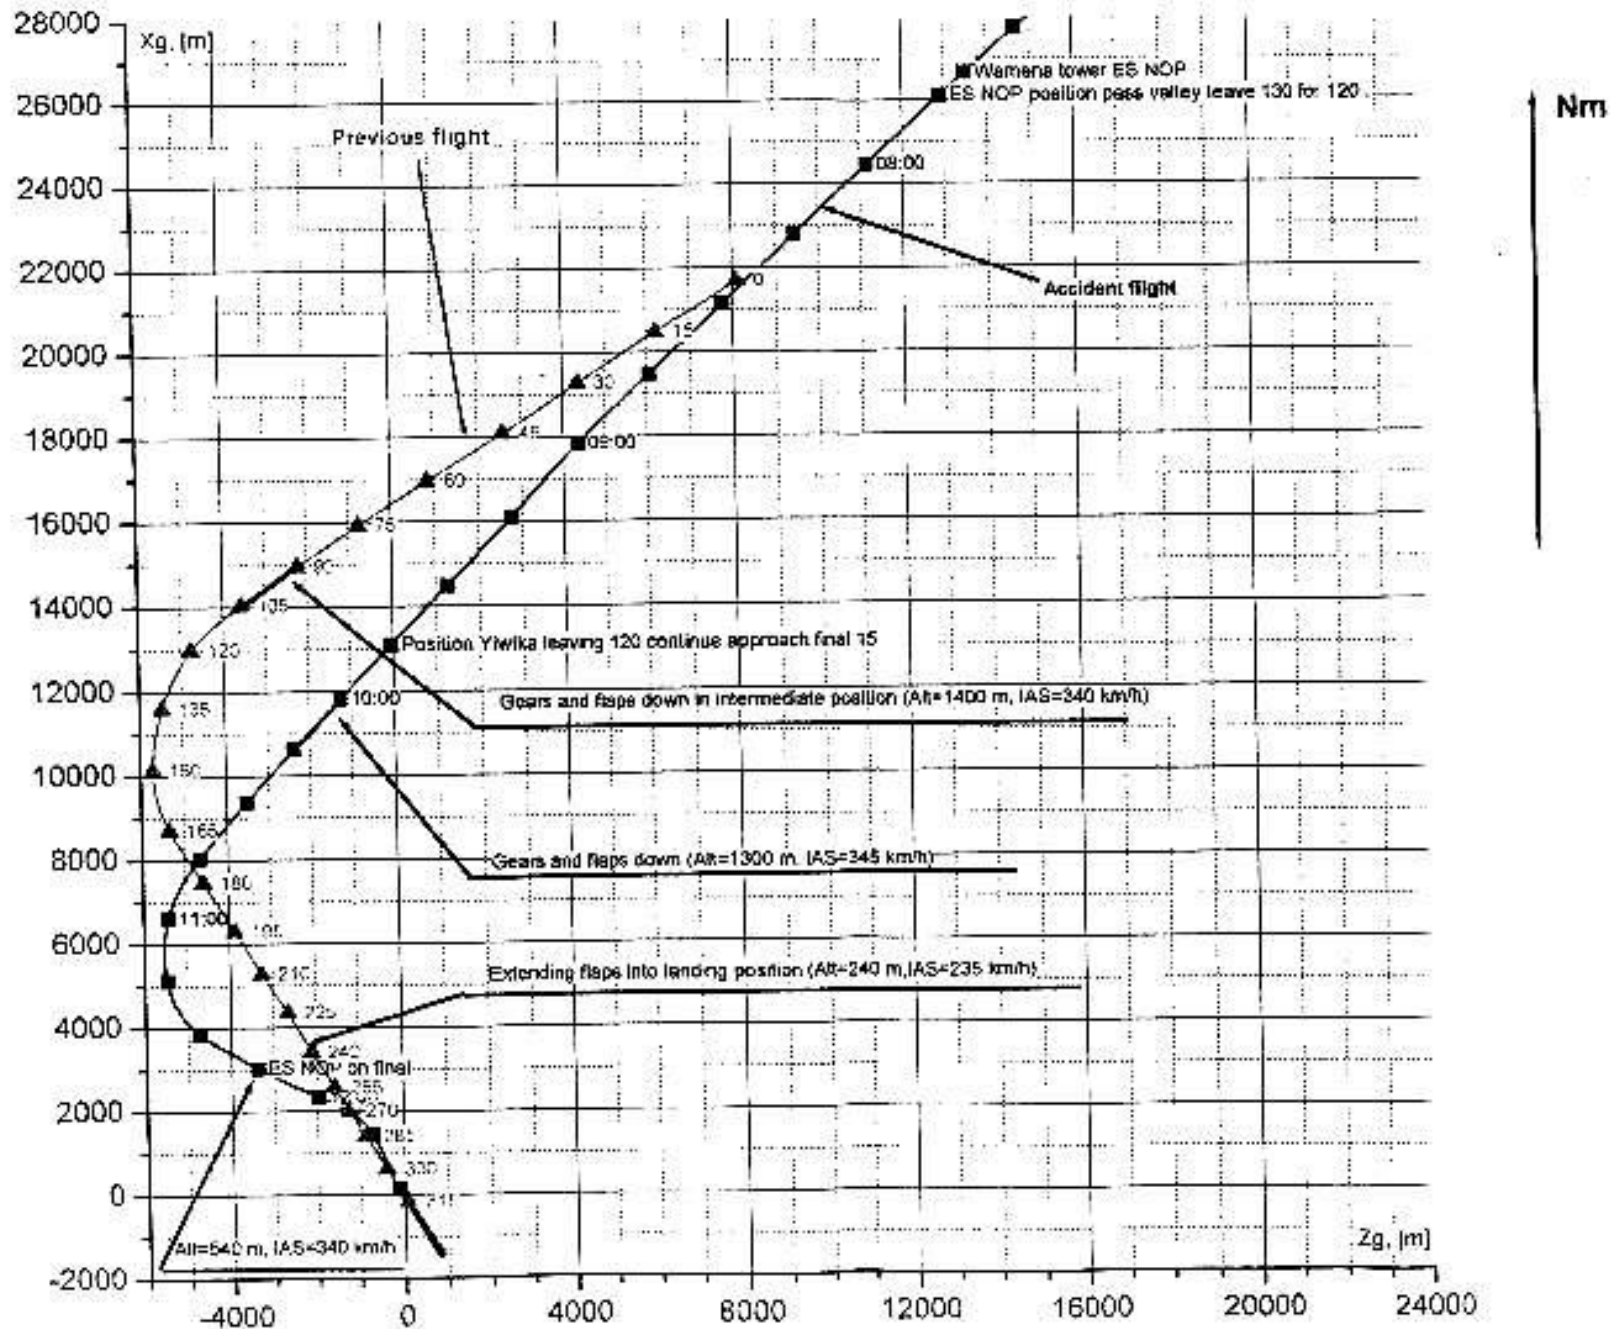
Pic. 4 Flight path of the Antonov 72 aircraft on April 21, 2002 while landing in Wamena airport

Therefore, it can be concluded that the aircraft was over speed upon the accident landing. The FDR analysis also noted that the aircraft never fully deploy its flap due to over speed on final (see 0).

- ◆ The crew performed visual approach to Wamena airport at airspeed exceeded the provision on AN-72 manual
- ◆ The crew failure to estimate distance to start the final turn properly made the unable to decrease speed and therefore unable to extend flap to landing configuration.
