**Aircraft Serious Incident Investigation Report**

**PT. Merpati Nusantara Airlines**

**De Havilland DHC 6-300 Twin Otter; PK-NUH**

**17 October 2011**

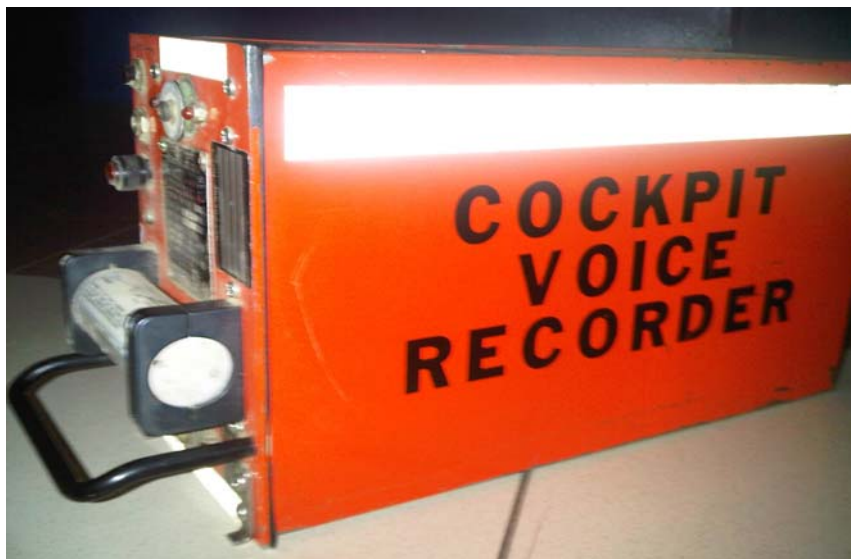
**Figure 4. PK-NUH Cockpit Voice Recorder**

The CVR was recovered from the accident site the day after occurrence. The analysis of the CVR will be mention in the final report.
