PRELIMINARY
KNKT.10.01.01.04

Aircraft Serious Incident Investigation Report

Antonov AN-26B; 4L-IFE

Wamena Airport, Wamena, Papua

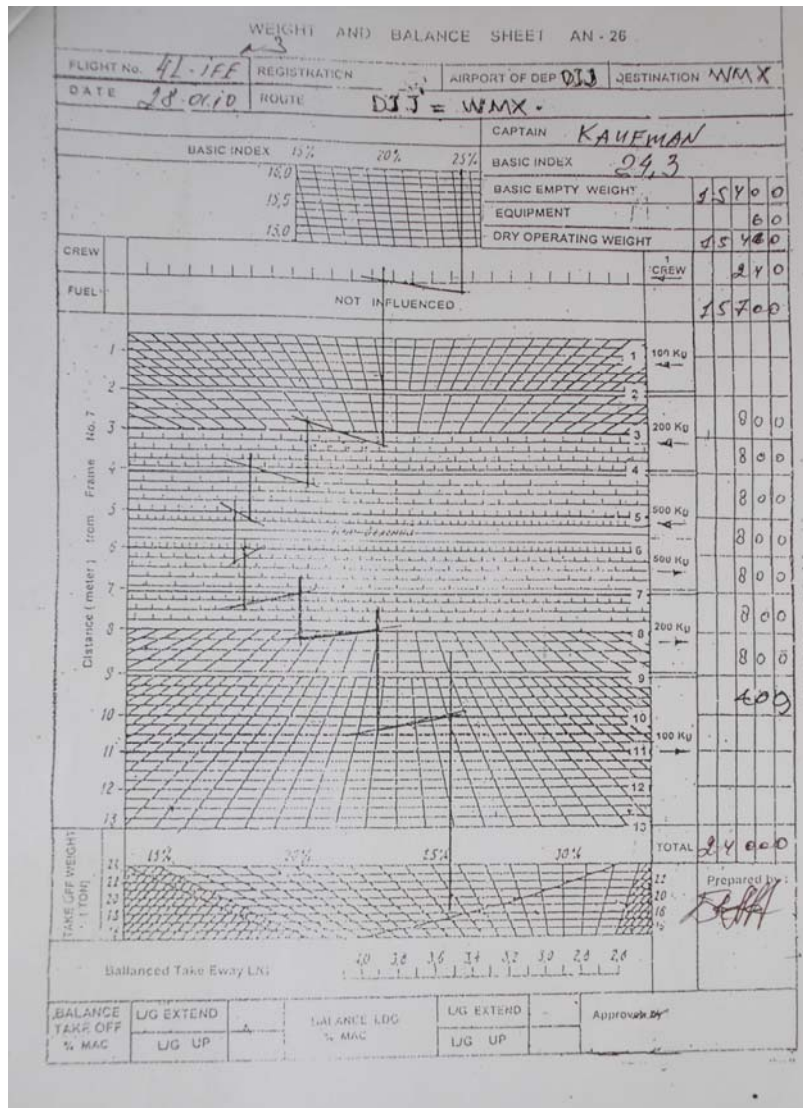
Figure 5: Load sheet used on the flight

The operator provided the following completed weight and balance sheet that was used for the accident flight.

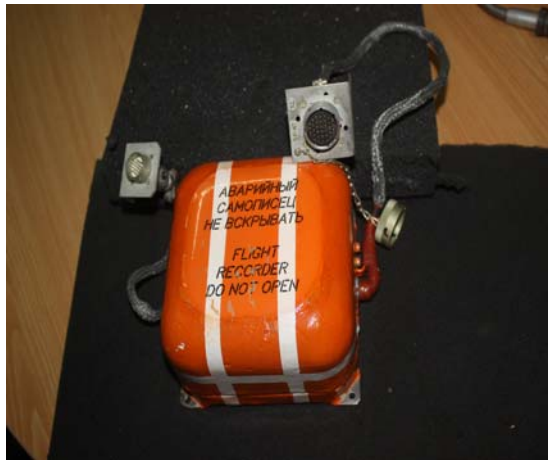
Figure 7: The Flight Data Recorder

The aircraft was equipped with a Flight Data Recorder (FDR) and a Cockpit Voice Recorder (CVR). Search and Rescue personnel recovered the FDR and CVR from the wreckage and handed them over to NTSC investigators.
